Beach Changes on Oahu as Revealed by Aerial Photographs

Dennis Hwang

July 1981

Technical Supplement Number 22, Coastal Zone Management Project,
Urban and Regional Planning Program
Technical Report HIG-81-3, Hawaii Institute of Geophysics
Cooperative Report UNIH-SEAGRANT-CR-81-07, UH Sea Grant College Program

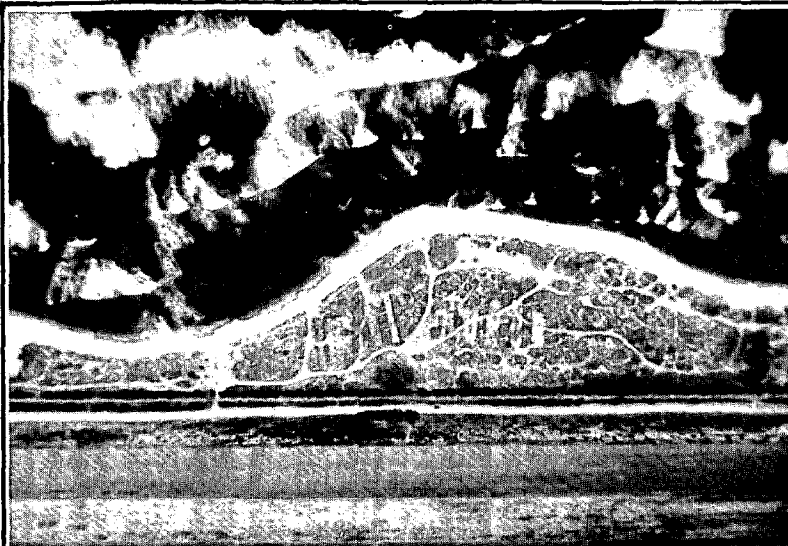
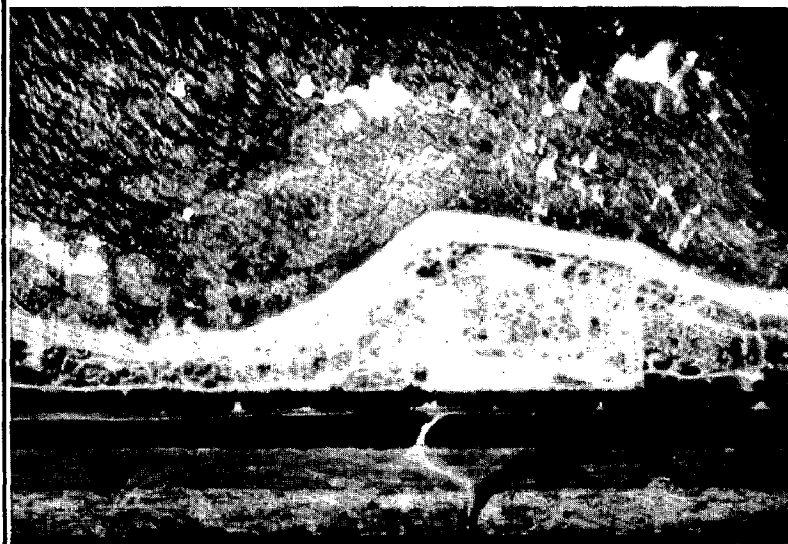
Plate 1. Mokuleia Beach (West End). Possible inundation from the 1957 tsunami at Mokuleia Beach (opposite the middle of Dillingham Airfield). The light streaks on the right side of the 1958 photograph are attributed to sand mining.

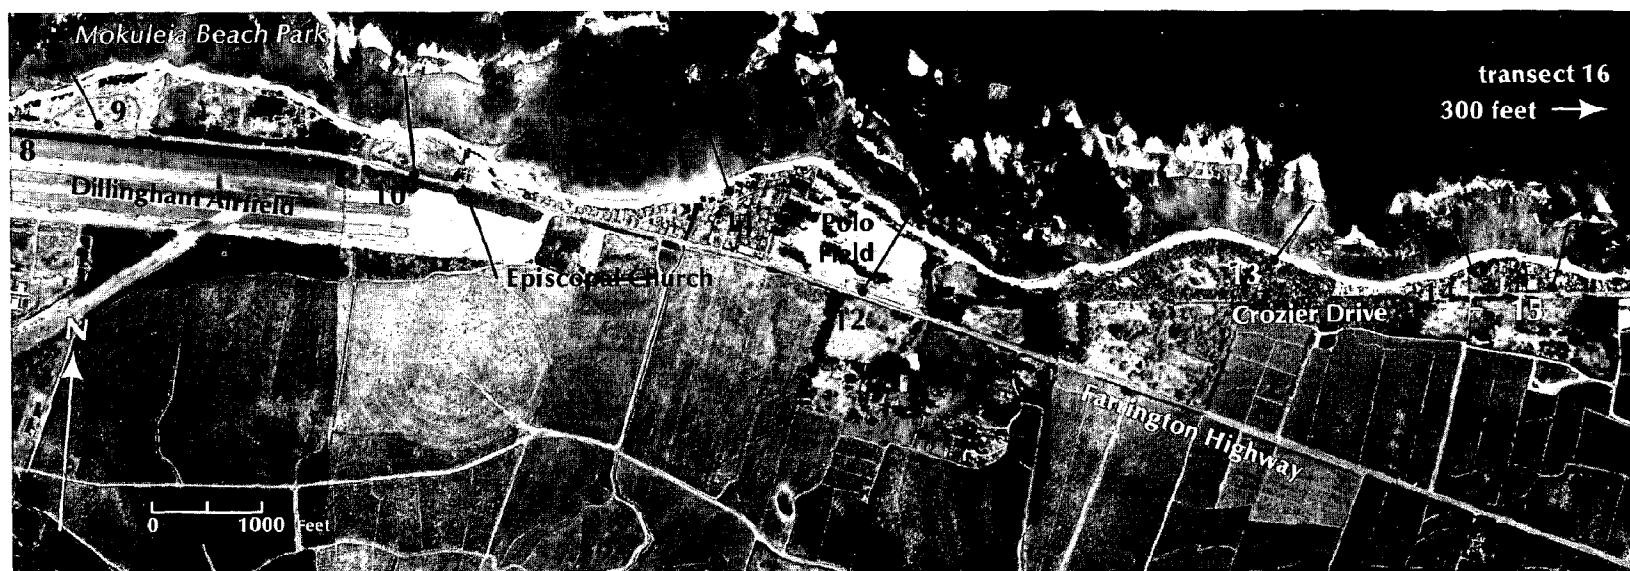
Photomap 2. Mokuleia Beach (Middle Section)

Photographs by Air Survey Hawaii: March 1971

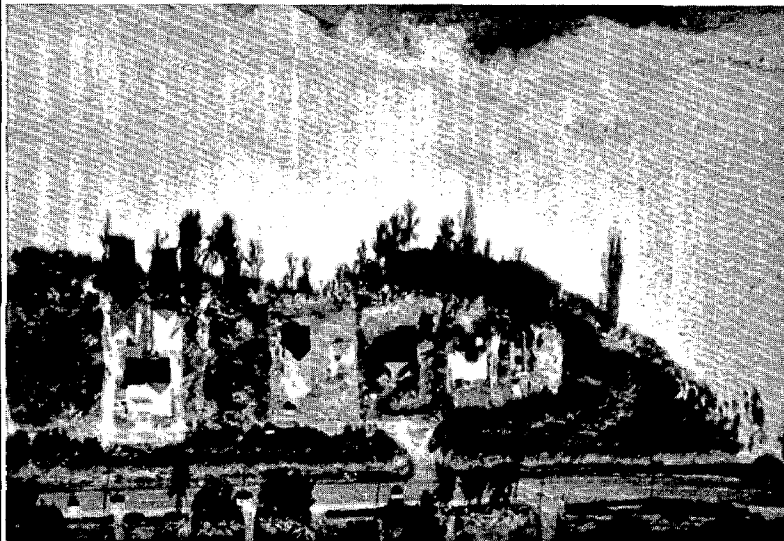
Plate 2. Sunset Beach (West End). Damage from the December 1-4, 1969 storm at west Sunset Beach. Note the recession of the vegetation and the houses missing on the 1971 photograph.

The severe damage at Sunset caused by the 1969 storm is explained in a post-flood report (State of Hawaii, DLNR, 1970). One of the worst-stricken areas was at the west end of Sunset Beach, in front of Ke Iki Road. An examination of the 1967 and 1971 photographs shows that at least two houses were swept off their foundations by the large waves (Plate 2). In all, 14 houses were demolished along this stretch.

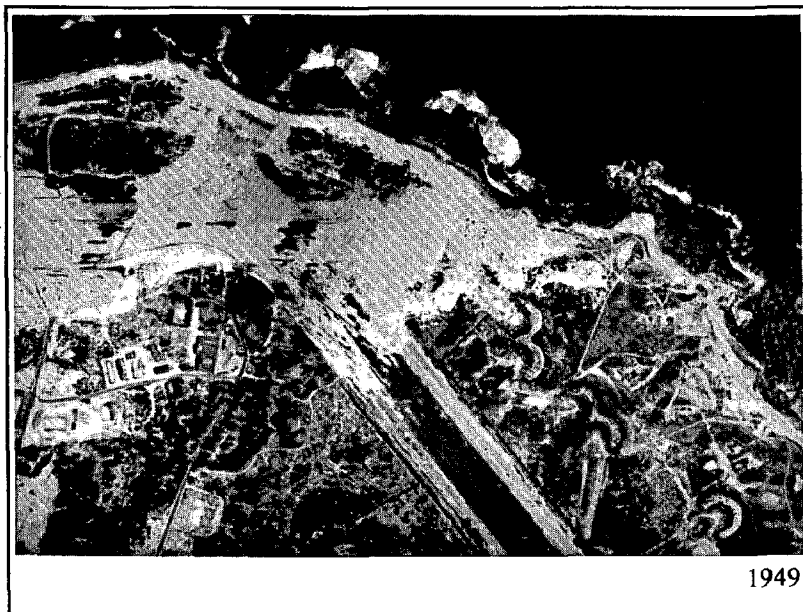
Plate 3. Kahuku Airfield. Sand washed ashore by the 1946 tsunami is shown on the 1949 photograph of Kahuku Airfield.

The tsunami inundation at Kahuku Airfield was aided by the smooth surface of the runway. Waves lost little energy in crossing this feature. As a result, structures more than 1,200 feet inland were threatened by runup. For more information on the damage caused by the 1946 tsunami, the reader is referred to Shepard et al., 1950.

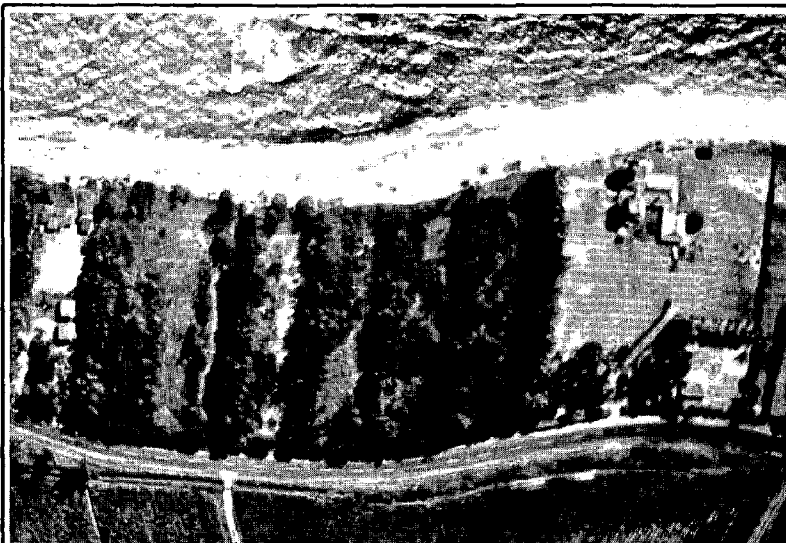
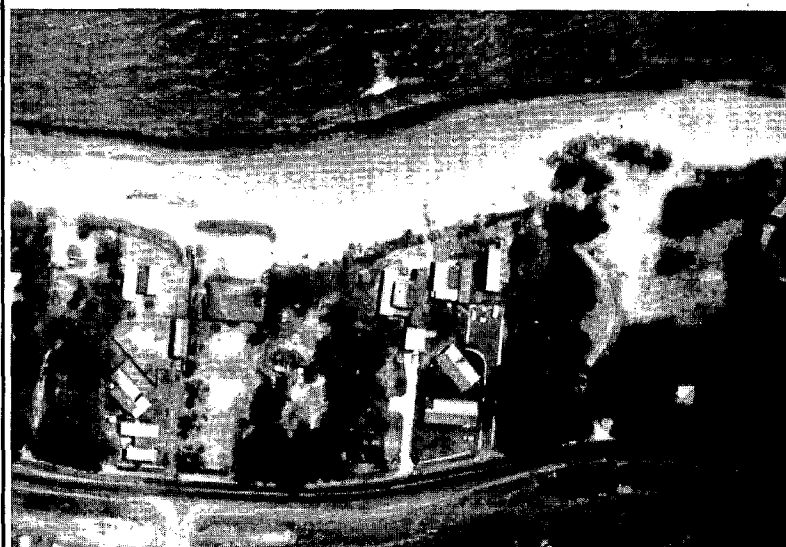
Plate 4. Laniloa Beach. Between 1949 and 1975, chronic erosion at Laniloa Beach resulted in a 70-foot retreat of the vegetation line. Note the trees on the beach on the 1949 photograph. Compare the position of the vegetation line with the highway on the 1949 and 1975 photographs.

The middle and south sections of Laniloa Beach (transects 4-7) have a history of severe erosion. The worst problem is located on a 500-foot section of the beach near transect 5. An examination of the 1949 aerial photograph shows fallen trees on the beach, an indication that erosion had occurred previously. Since 1949, the beach at transect 5 has receded for all five observation periods. Between 1949 and 1975, the vegetation line eroded 70 feet (Plate 4).

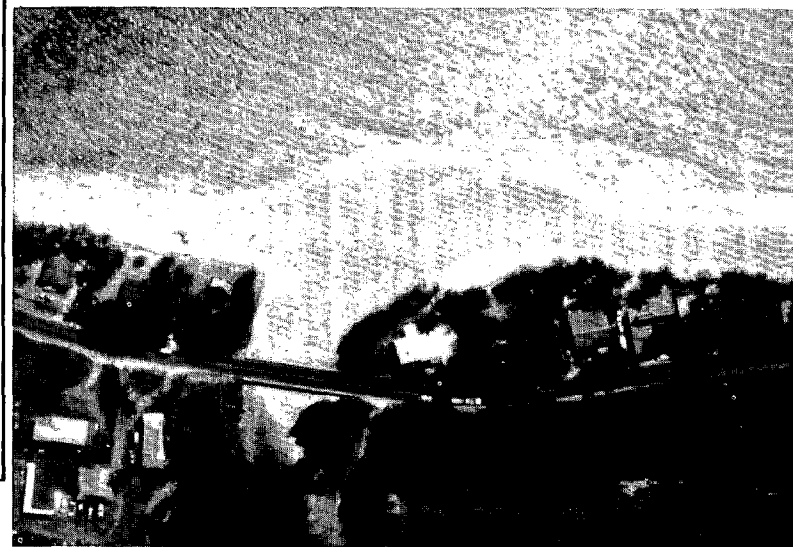
Plate 5. Kaluanui Beach. Accretion to the south of Kaliwaa Stream. Note the houses built on the newly formed land.

The residential area at transect 2 is completely spanned by seawalls. At the south end of this stretch, a wall was constructed perpendicular to the shoreline to provide flood protection from Kaliwaa Stream (Photomap 20). This structure and the stream tend to trap sand transported from offshore or along the coast. Immediately to the south, at Kaluanui Beach, accretion in the vegetation line of approximately 75 feet has occurred over a 26-year period. A major residential area has been built on this accretion plain (Plate 5).

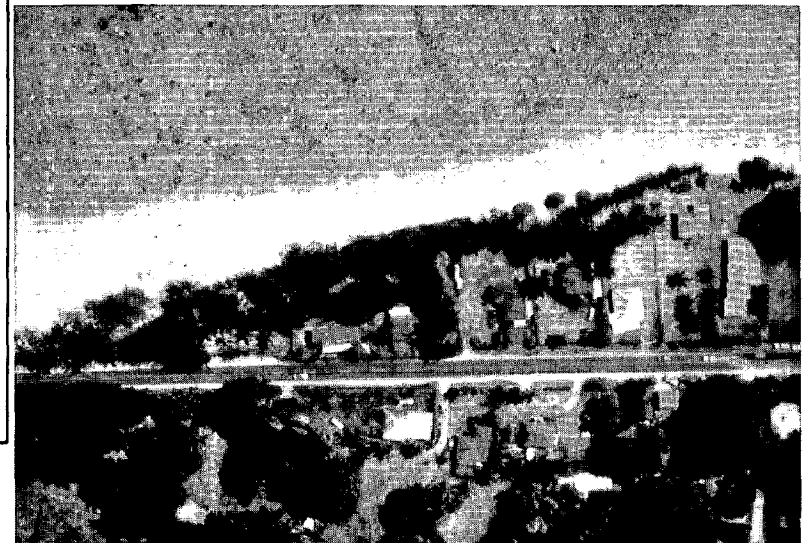
Plate 6. Punaluu. Over a 26-year period, the vegetation line for the beach at Punaluu grew seaward 56 feet. Compare the position of the vegetation line with the highway on the 1949 and 1975 photographs.

At the residential section of Punaluu, field surveys indicate that the vegetation line advanced seaward 18 feet during the 1962-1972 period (J. F. Campbell, unpub. data). From aerial photographic measurements, the vegetation line accreted 63 feet over a 30-year period (Plate 6). It appears that sand from the nearby reef is an important contributor to this beach.

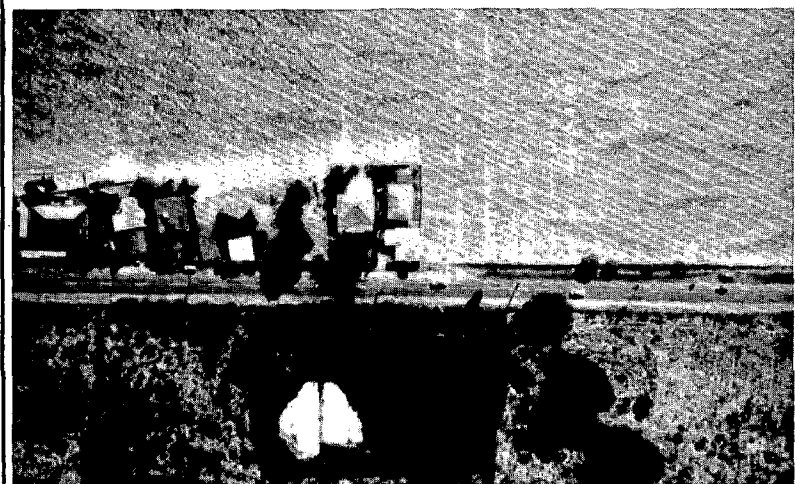
Plate 7. Kualoa. Between 1928 and 1978, erosion to the south (right) of the groin has stripped the protective beach and vegetation fronting the highway.

- (1) To the north of the beach park, the stretch of shoreline along the highway has been severely altered by a series of groins (Photomap 25). Immediately upcurrent of each groin, the beach has been stable or grew. The net changes in the vegetation line for transects 1 to 4 are less than 10 feet (Table 25). Downcurrent of each groin, the beach has been starved (Plate 7). Along several sections of the coast, only a seawall protects

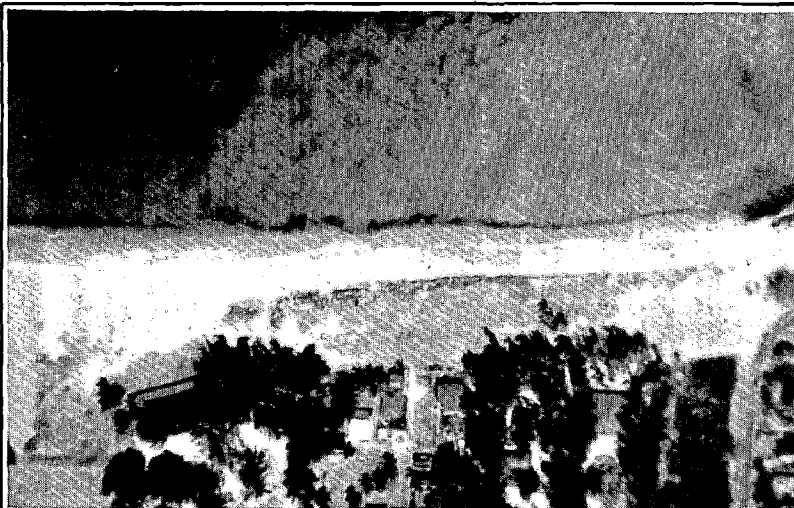
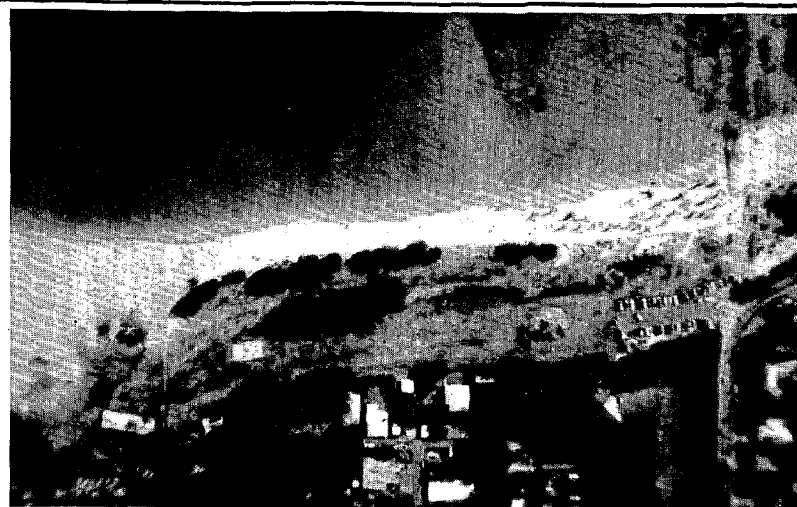
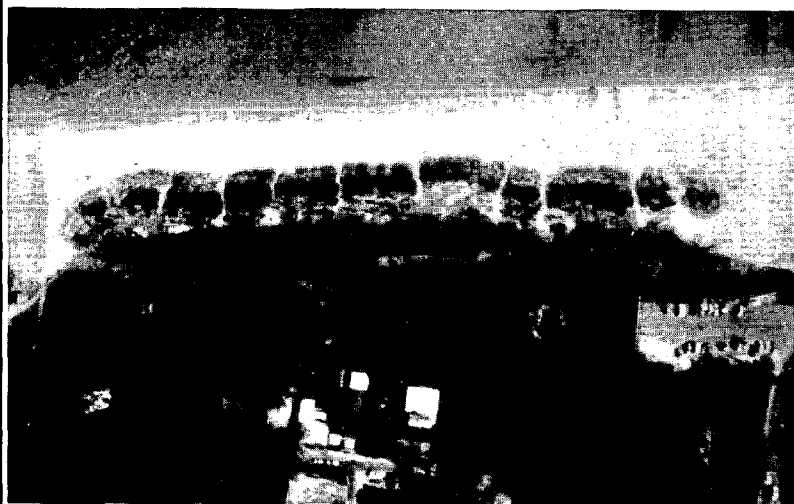
- (1) During the period from 1949 to 1971 the vegetation line in front of transect 13 grew seaward about 128 feet. Within this time interval, two rows of trees were planted approximately 95 feet and 40 feet inland of the 1971 vegetation line. Between 1971 and 1978, the vegetation line retreated about 119 feet to the position where the 1978 vegetation line was within 10 feet of its 1949 location. As a result many trees fell in the water (Plate 10).

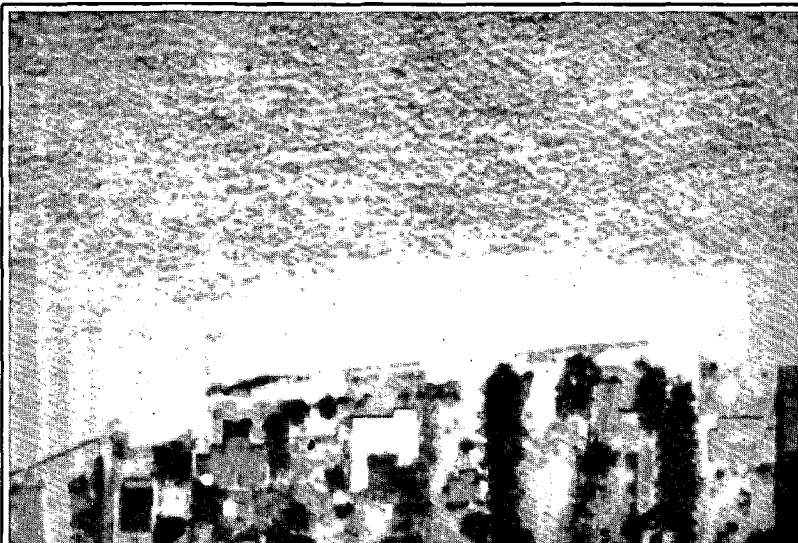
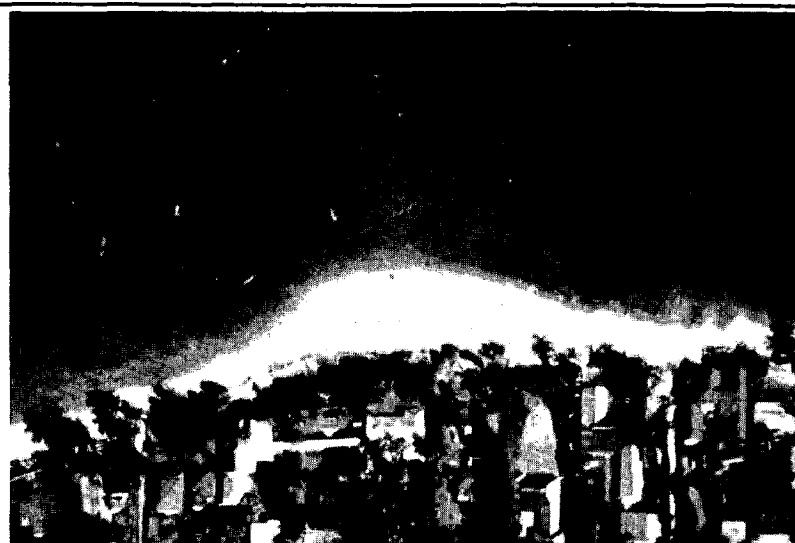
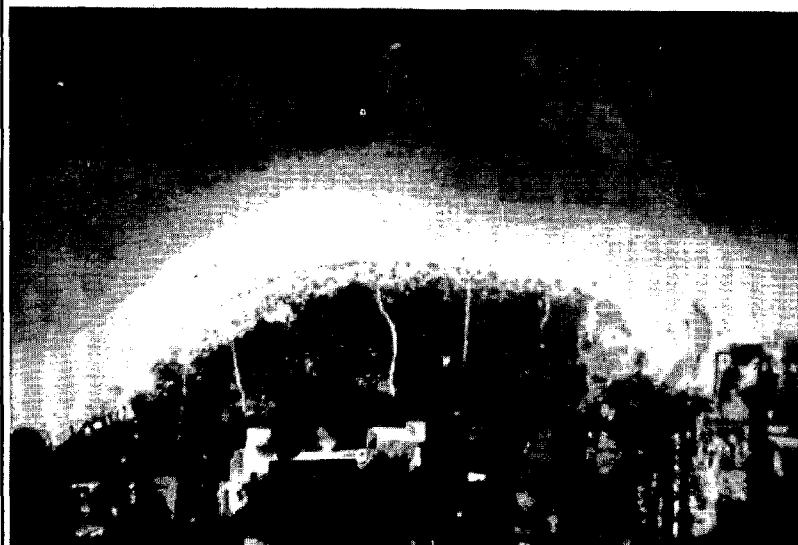
Plate 11. Lanikai Beach. The accretion-erosion cycle at south Lanikai Beach is depicted in these aerial photographs. Between 1950 and 1971, the vegetation line had a net change of +131 feet. This accretion was concentrated during the 1961 to 1971 interval. Over the next nine years, erosion of 111 feet occurred.

During the 1961 to 1971 period, the vegetation line at the south end of Lanikai grew seaward by 139 feet. From 1971 to 1980, the trend reversed, and the vegetation line eroded 111 feet at a rate of about 12 feet per year (Photomap 27, Plate 11). This accretion-erosion cycle coincides in timing and magnitude with the one for Kailua Beach Park.

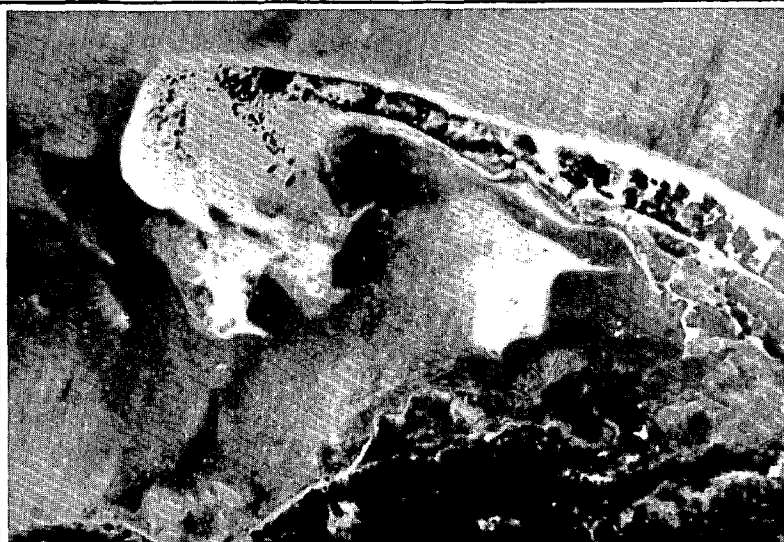
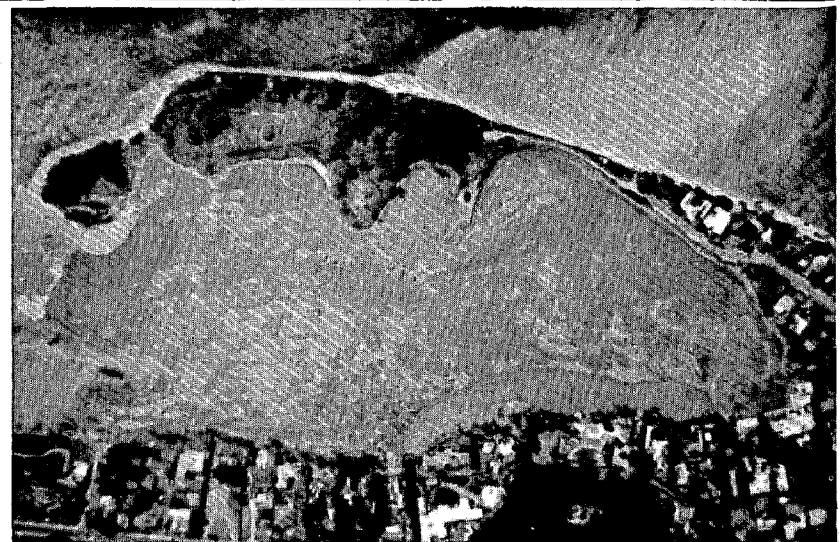
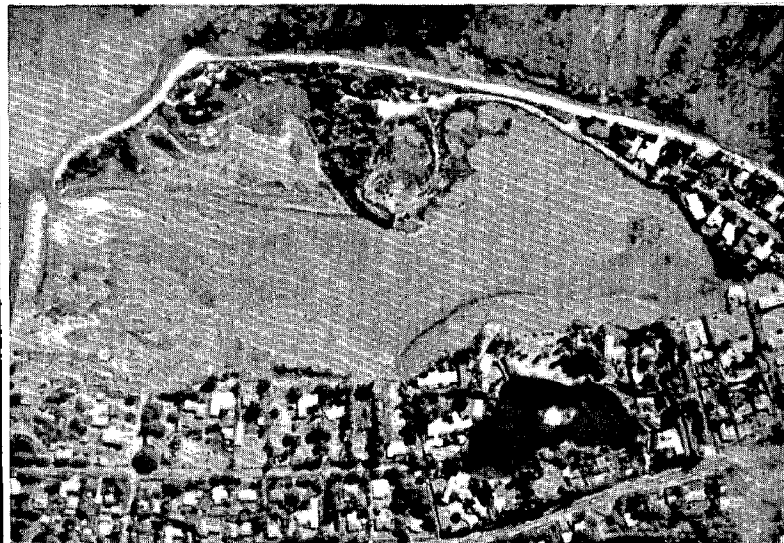
Plate 12. Paiko Peninsula. During the 1928 to 1961 interval, Paiko Peninsula grew over 900 feet to the east (left). Since 1961, the shape of the peninsula has been modified artificially.

Between 1928 and 1949, the tip of Paiko Peninsula grew eastward about 550 feet (Table 33, Plate 12). This extension to the east occurred at an average rate of over 25 feet per year. Meanwhile, the arm of the spit thinned considerably. If not for a rock wall built along the shoreline, the eastern end of the peninsula might have separated and become a barrier island.

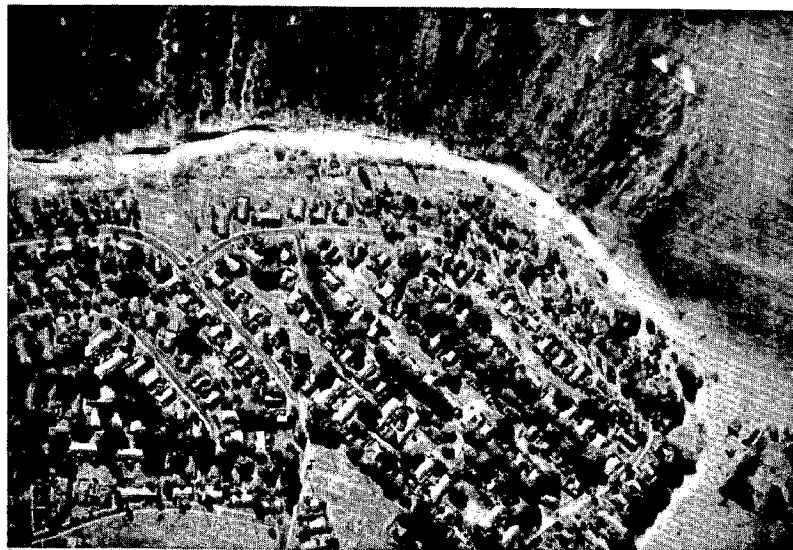
Plate 13. Iroquois Point. Over a 48-year period, erosion at west Iroquois Point (Keahi Point) has been over 180 feet. Compare the shape of the point on the 1928 and 1976 photographs.

From 1928 to 1976, the vegetation line and water line receded about 180 feet (Table 38, Plate 13). The rates of erosion for the vegetation line were not constant but varied from 1.2 feet per year during the 1961 to 1967 period, to 4.7 feet per year between 1967 and 1976.
